Walk Audit Report

Eureka's 4th & 5th Street Corridor (US-101)

October 2024

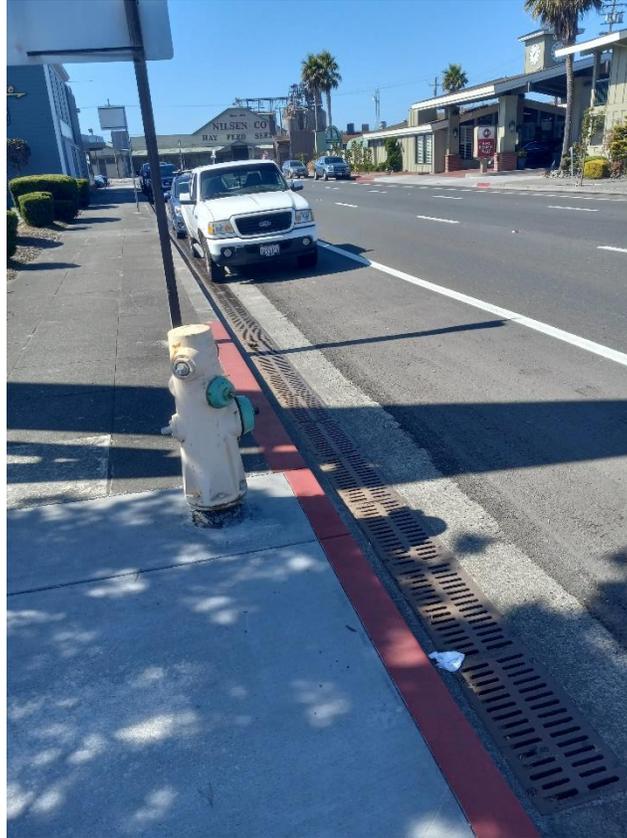
Many participants noted that numerous drivers parked too close to crosswalks, which limited the ability of drivers to see pedestrians at the curb as well as the ability of pedestrians to see approaching vehicles. This problem was worsened by another major problem noted by walk audit participants, the lack of downstream⁵ crosswalk markings at many intersections. A pedestrian at the marked (upstream) crosswalk, while potentially more visible to turning drivers approaching from a side street, is less visible to drivers on 4th or 5th Street, especially when vehicles are parked too close to the intersection.

Figure 5: Despite being parked behind the red curb, a pick-up truck blocks pedestrian visibility on 5th Street

Paint red curb to prevent parking for at least 20 feet, and perhaps more, on the “upstream” side of all intersections, thus “daylighting” the crosswalks. Additional pavement markings can be used to emphasize the no-parking zone.

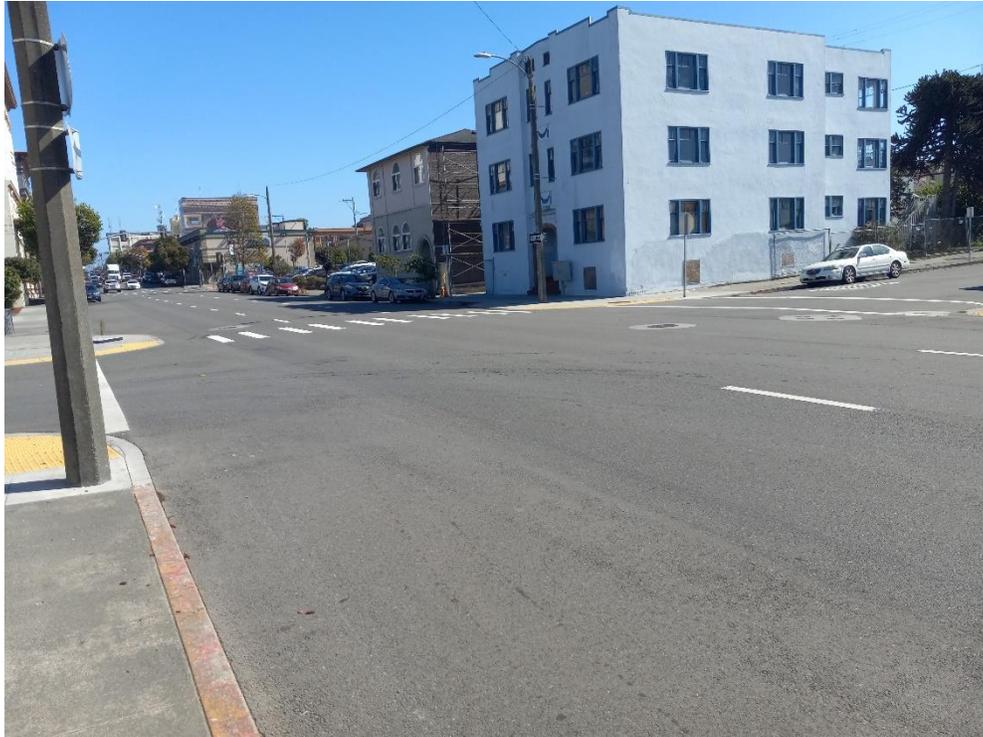
The lack of crosswalk markings also means that drivers may not expect pedestrians to use these (still legal) crossing locations. The situation requires pedestrians to either use the unmarked crosswalk or potentially cross three legs of an intersection rather than one, increasing exposure to vehicles and therefore crash risk.

Figure 6: A typical unsignalized intersection on 4th Street, lacking downstream crosswalk markings.

Add high-visibility (e.g., ladder-style) crosswalks to all intersection legs.

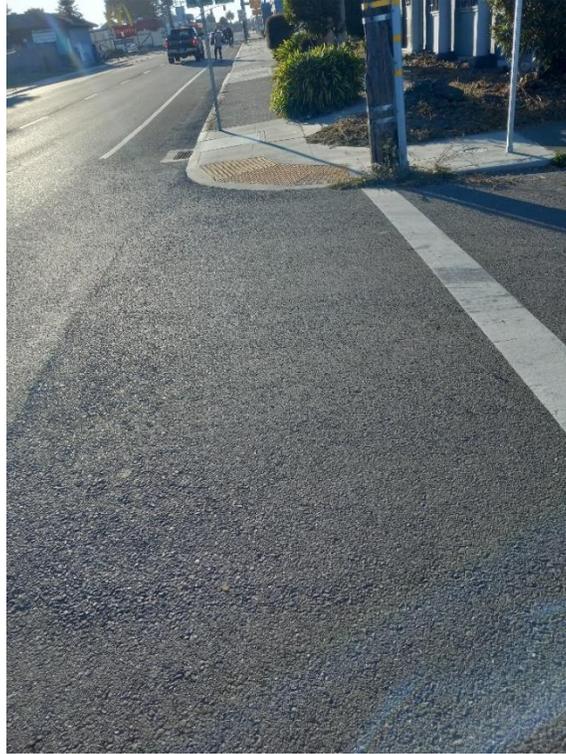
Participants noted that many side street crosswalks are entirely unmarked. Even when markings are present, many drivers were observed to pull into the crosswalk before stopping to assess oncoming traffic, potentially due to poor visibility (see comments above on parking near intersections).

Figure 7: Missing crosswalk markings on T Street at the intersection with 4th Street.

Add high-visibility (e.g., ladder-style) crosswalks to all intersection legs.

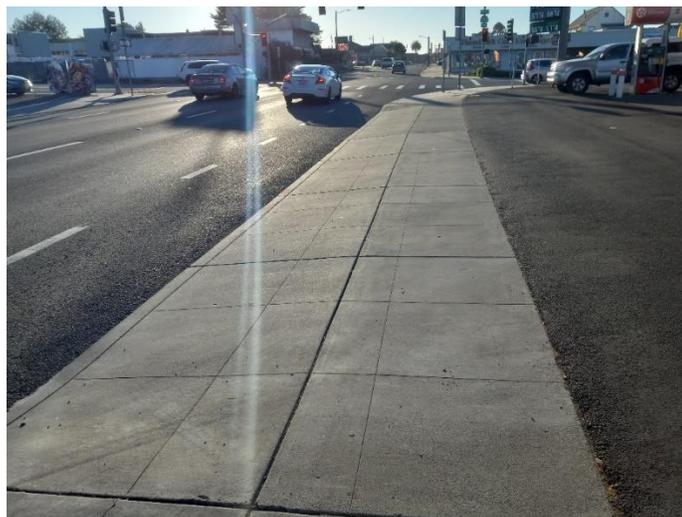
Participants noted that there were many driveways on some blocks, and some of the driveways were very wide, increasing pedestrian exposure to turning vehicles and decreasing safety.

Figure 8: A very long driveway/curb cut at a gas station at 4th Street and R Street/SR-255.

Remove redundant driveways. Reduce the width of remaining driveways, and reduce the turning radius to reduce turning speeds.

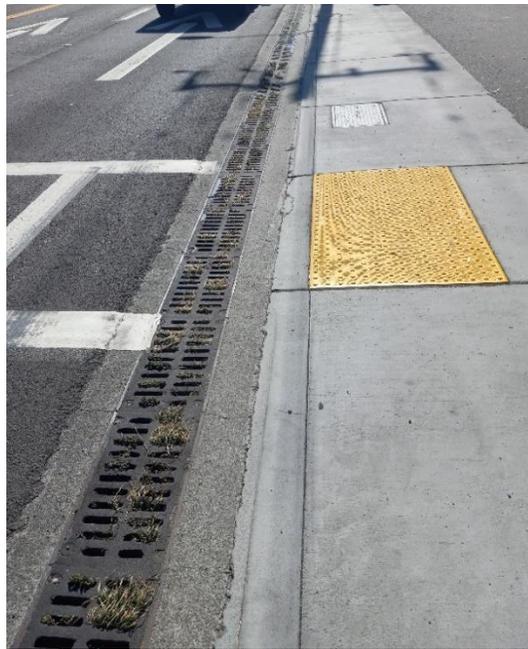
Participants noted many locations with cracked or uneven sidewalks, truncated dome panels which were coming loose at the edges, empty tree wells, and open drainage grates. Participants identified all these features as potential tripping hazards and potential obstacles for users of wheelchairs, canes, and other mobility devices.

Figure 9: A drainage grate on Broadway identified as a hazard for cane users.

Ensure regular sidewalk maintenance, and plant street trees that improve the environment without obstructing pedestrian traffic or causing sidewalk cracking or buckling. Ensure drainage grates do not include wide enough holes for canes or small wheels to get stuck.

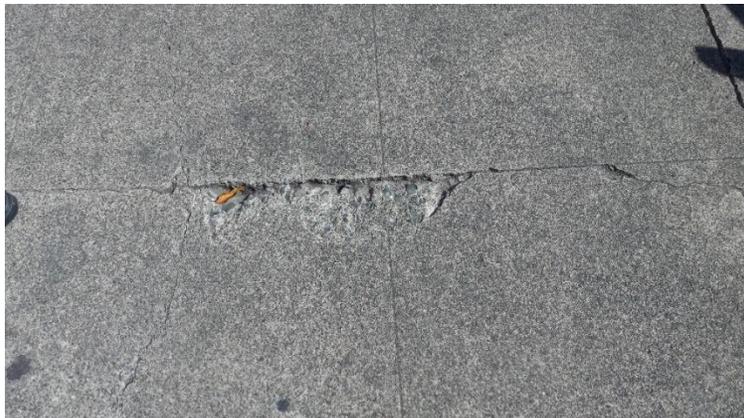
Figure 10: A hole in a sidewalk requiring maintenance.

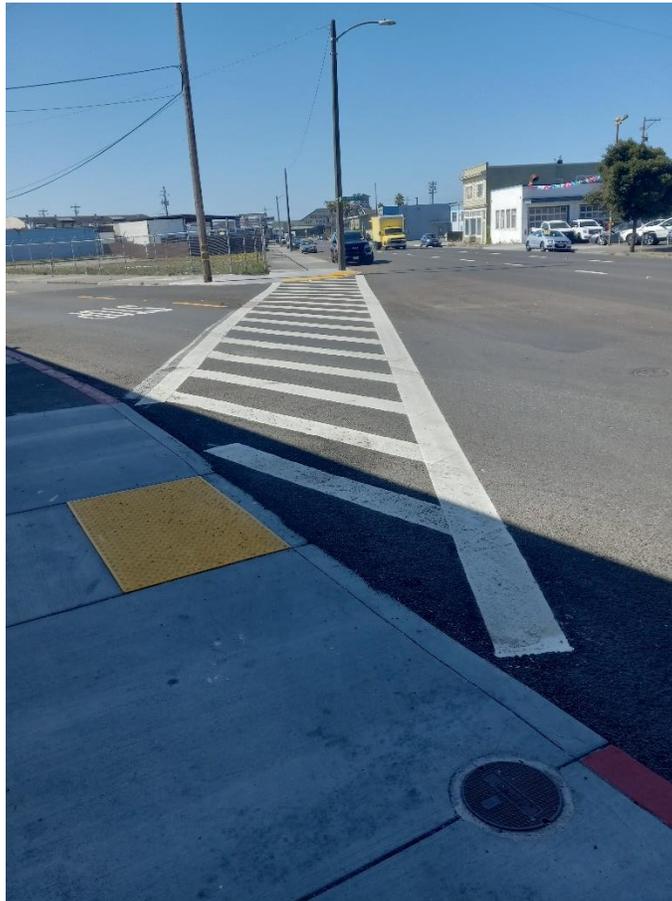
Walk audit participants noted many locations where curb ramps pointed diagonally into the middle of an intersection, rather than directly into the crosswalk, which could create a hazard for blind or low-vision pedestrians attempting to follow the ramp direction.

Figure 11: A curb ramp at 5th Street and Summer Street leads into 5th Street instead of into the crosswalk.

Angle curb ramps directly into marked and unmarked crosswalks.

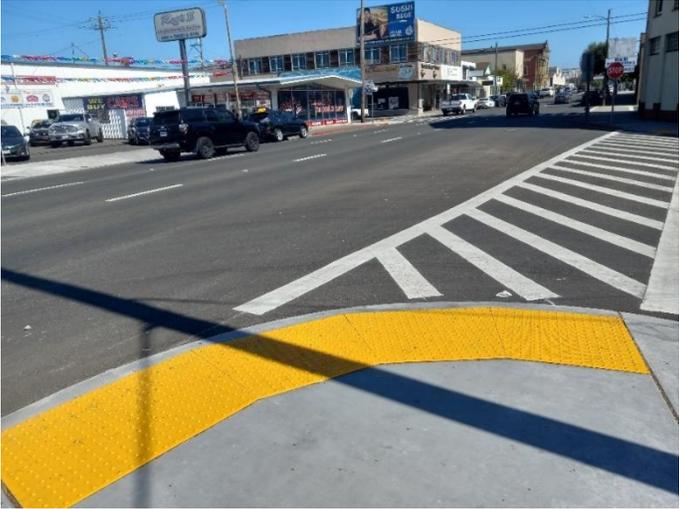
In many locations in the corridor, rather than curb ramps, there is a “blended curb.” Walk audit participants with expertise in accessible design reported mixed reactions to this design. One liked the

design for wheelchair accessibility, while another was concerned about the lack of tactile direction for blind or low-vision pedestrians which is provided by a properly oriented curb ramp.

Figure 12: An example of a "blended curb" at 5th Street and Summer Street.

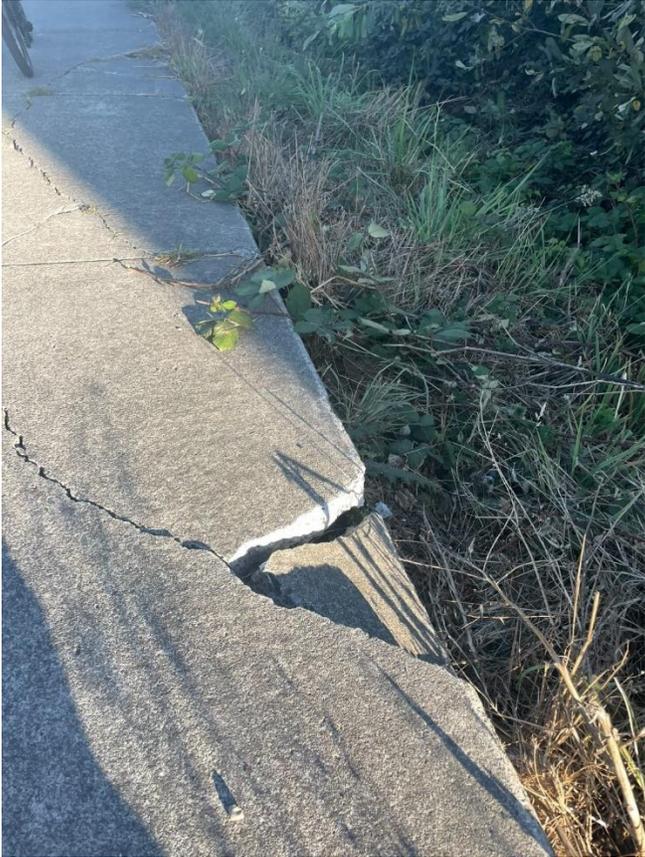
Other potential accessibility hazards noted by participants include a steep sidewalk drop-off with no protective barrier on 5th Street near V Street.

Figure 13: A collapsing sidewalk edge on 5th St near V St on the edge of a steep hillside

Provide a curb or other barrier at the edge of sidewalk as appropriate.

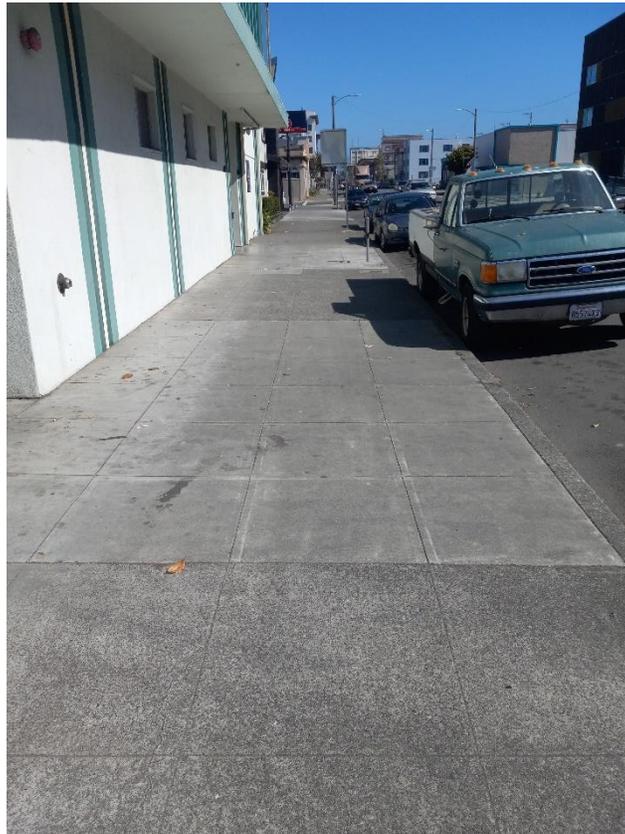
Walk audit participants noted that sidewalk widths vary significantly throughout the corridor. Participants appreciated the wide sidewalks found in most of the western part of the corridor (e.g., from Broadway to D Street), as well as at the 4th & U Street bus stop and west of T Street on 4th Street.

Figure 14: A typical wide sidewalk in the western part of the corridor.

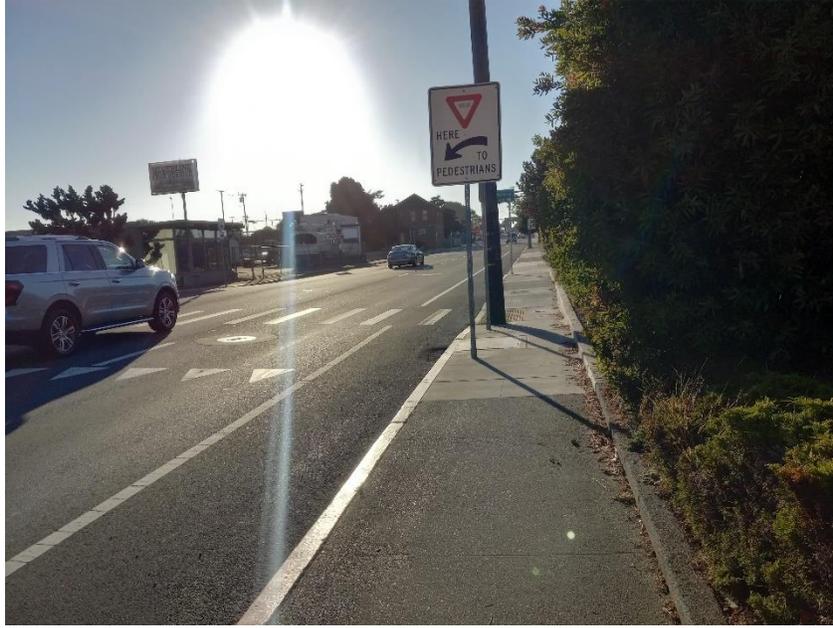
However, in some of the eastern part of the corridor (e.g., on 5th Street around V Street), sidewalks are uncomfortably narrow.

Figure 15: A narrow and obstructed sidewalk in the eastern part of the corridor.

Ensure that vegetation is managed to remove sidewalk obstructions and protrusions, and enforce temporary sign regulations. Over time, move permanent signs and utility infrastructure out of the pedestrian right-of-way. Where feasible, widen sidewalks to comfortable widths for high pedestrian volumes (e.g., 12 feet).

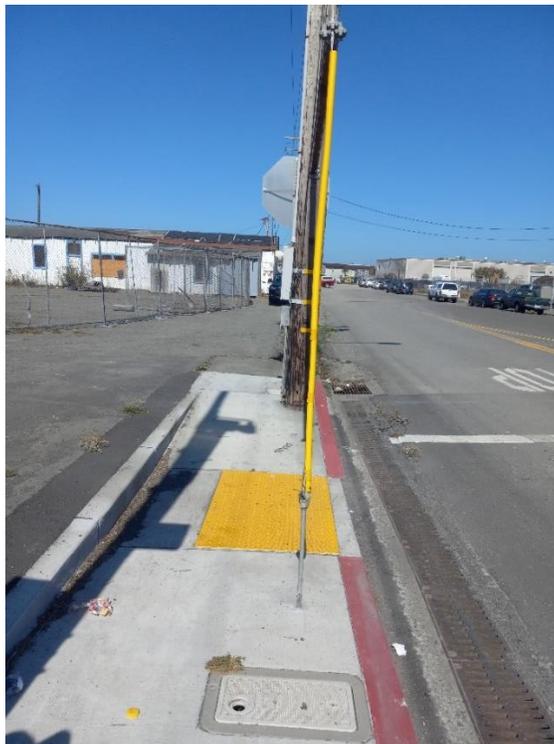
Even where sidewalks are wide, there are frequent obstructions which limit the usable width. Where sidewalks are already narrower, which is more common in the eastern part of the corridor, obstructions often limited accessibility or created uncomfortable conditions for passing or walking next to other pedestrians. Noted obstructions included overgrown vegetation, sign and utility poles, and temporary advertising signs.

Figure 16: Sidewalk obstructions on Broadway at 4th Street.

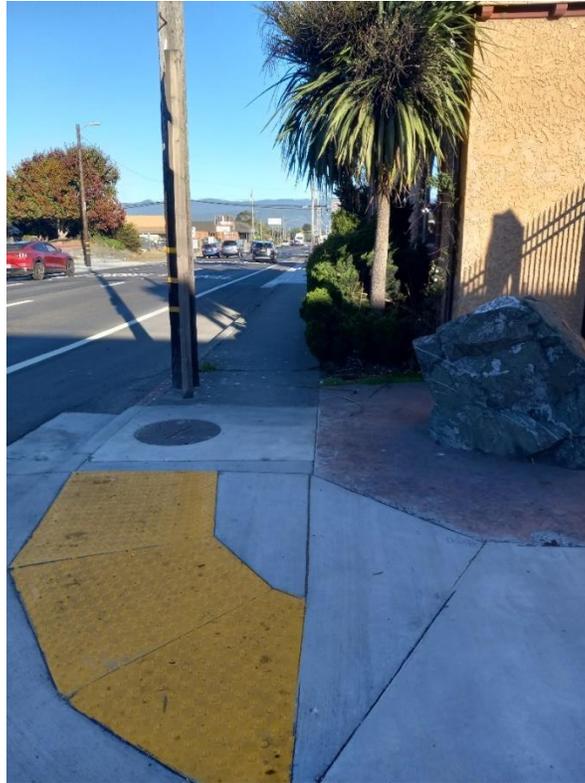
Figure 17: A utility pole and overgrown vegetation partially obstruct a sidewalk on 5th Street.

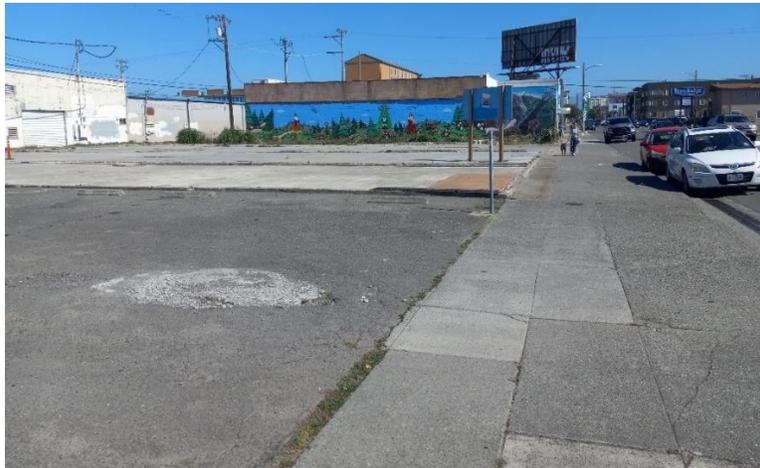
Walk audit participants commented that the corridor's land uses and development patterns sometimes create a hostile pedestrian environment. Participants noted vacant lots and barbed wire fences. In the eastern part of the corridor, participants noted drive-through businesses, and businesses facing away from the sidewalk or behind large parking lots.

Figure 18: Vacant lots on 4th Street near Broadway.

Amend zoning codes, land use regulations, and design guidelines to require pedestrian-oriented frontages. Prohibit new drive-through businesses. Encourage redevelopment of vacant lots with active uses.

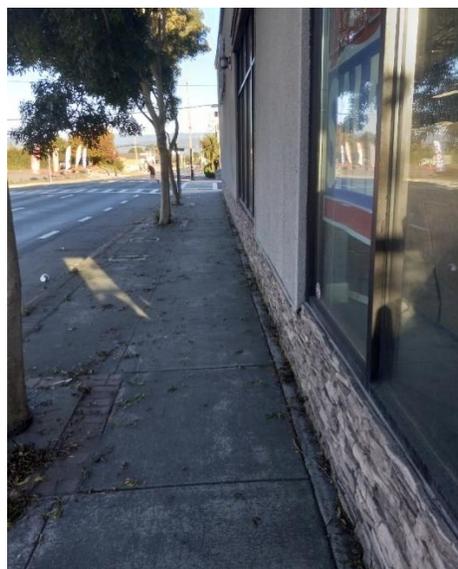
Figure 19: A pedestrian-unfriendly frontage on 5th Street in the eastern part of the corridor.

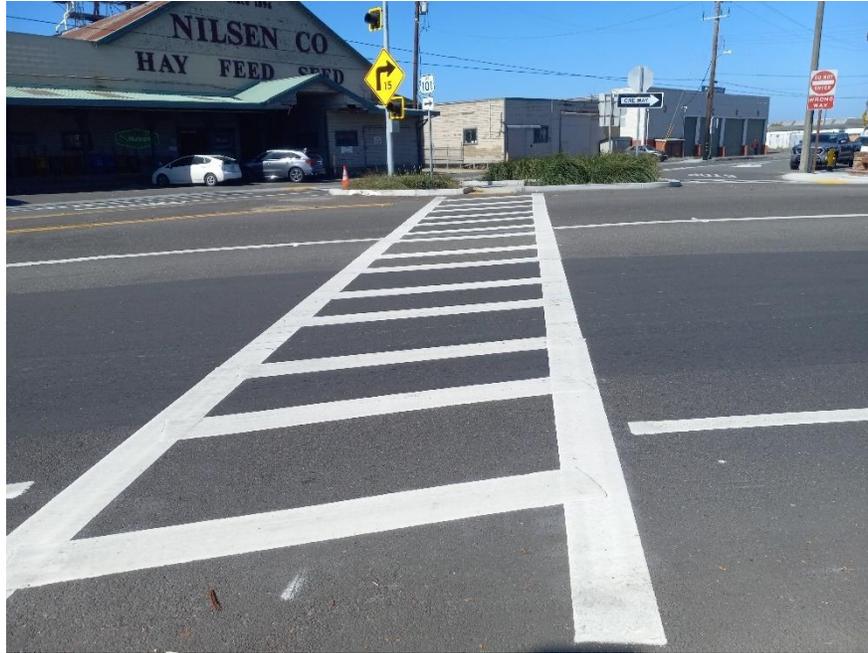
The crosswalk at the corner of Broadway and 5th Street made participants feel particularly uncomfortable and unsafe. Visibility is low due to the curve in the street, and drivers tend to speed. This problem is exacerbated by the lack of marked crosswalks on 5th Street between this intersection and A Street—a nearly ¼ mile gap in a busy pedestrian area.

Figure 20: The crosswalk at 5th Street and Broadway.

Provide a pedestrian hybrid beacon to increase likelihood drivers will see and stop for pedestrians.

Reduce the turning radius from Broadway onto 5th Street to lower traffic speeds.

Paint high-visibility crosswalks on all legs of all intersections on 5th Street.

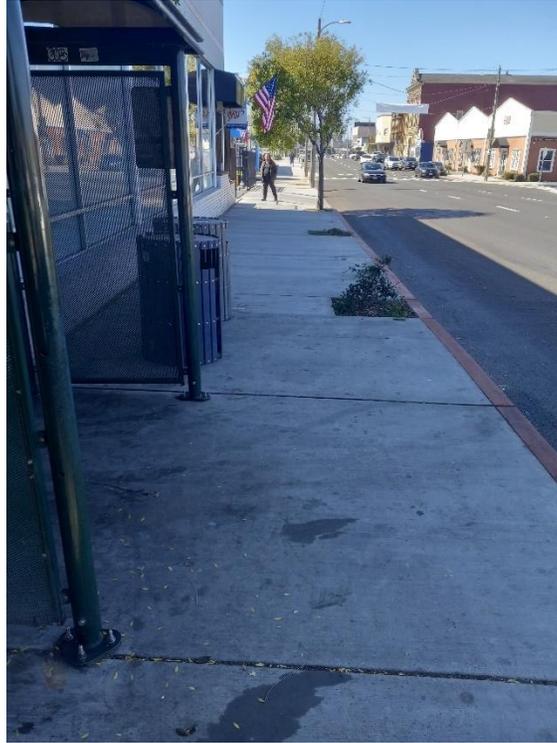
Participants noted the lack of seating at the 5th & D bus stop, along with a lack of space for riders to wait for the bus without blocking the sidewalk. Participants also noted a number of potential accessibility hazard and limitations.

Figure 21: The 5th & D Street bus stop, with no bench and empty tree wells identified as tripping hazards.

Provide seating at the bus shelter. Perform sidewalk maintenance as needed, and plant street trees which improve the environment without obstructing pedestrian traffic or causing sidewalk cracking or buckling. Consider providing a curb extension or boarding island to provide more space for waiting bus riders.

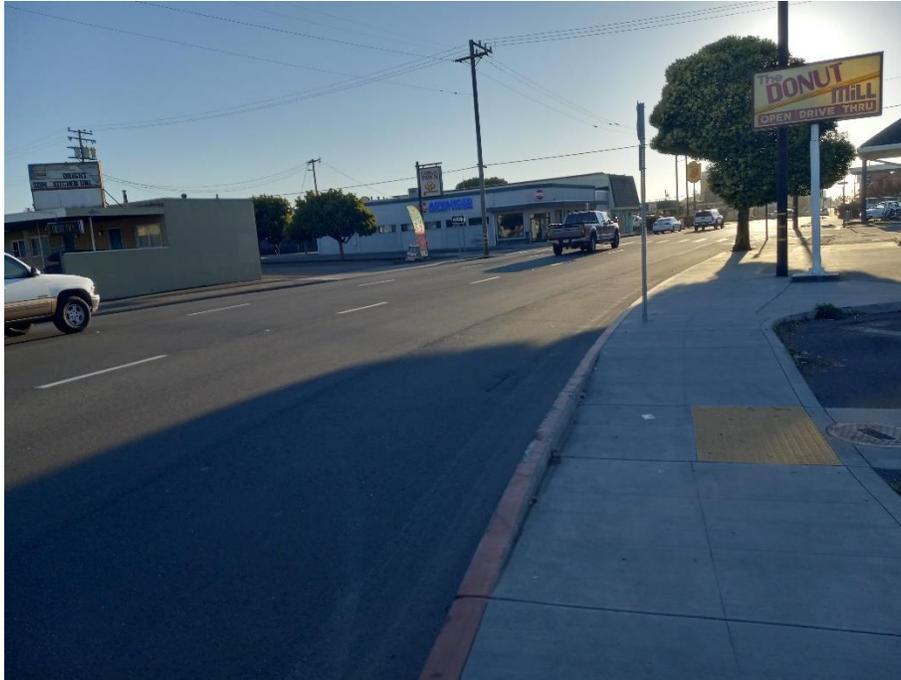
Much like when crossing at 5th and Broadway, participants said they felt particularly unsafe crossings 5th and 4th Streets at O Street due to the high speed and volume of traffic. The crossing at 4th Street felt especially unsafe due to limited visibility caused by the curve in the street. These dangerous crossings are routes not only to the bus stops on 4th and 5th Streets at O Street, but also to the nearby Humboldt County Library.

Figure 22: The 4th & O Street crosswalk from half a block away.

Provide pedestrian hybrid beacons or full traffic signals at the intersections of 4th & O Streets and 5th & O Streets. Employ additional traffic calming measures to reduce the speed of traffic.

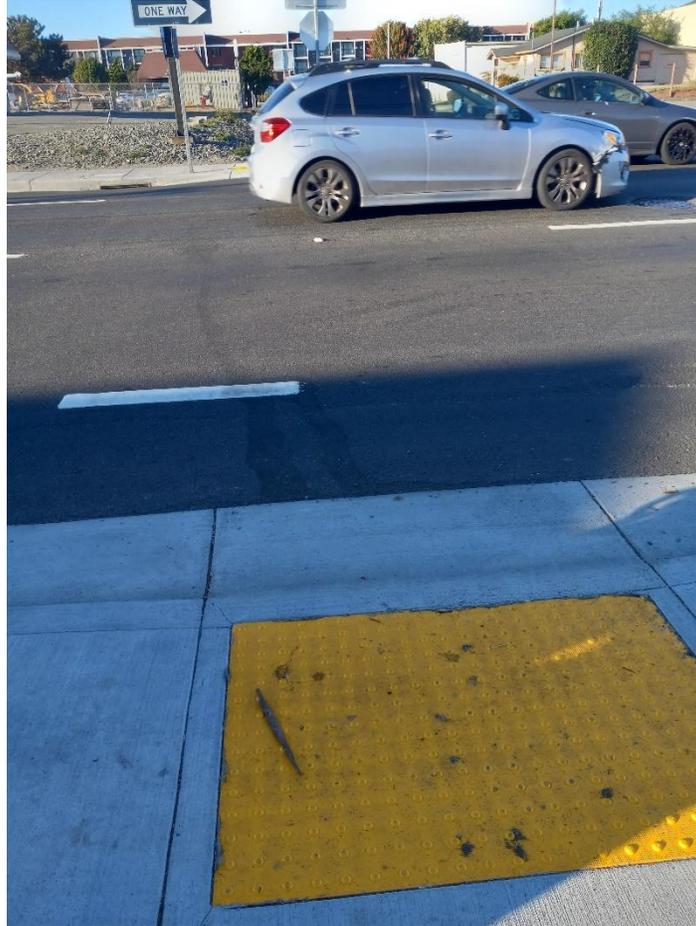
Participants appreciated the presence of bike racks and a bench at this bus stop, but noted that they were exceedingly dirty. Participants reported feeling generally unsafe in this area, and specifically noted that, despite high traffic volumes and speeds, the intersection of 5th & U Streets near the bus stop does not have marked crosswalks.

Figure 23: A curb ramp leads to an unmarked crosswalk at 5th and U Streets near the bus stop.

Provide high-visibility (e.g., ladder-style) crosswalks at all legs of the 5th & U Street intersection. Provide additional traffic calming measures to reduce the speed of traffic.

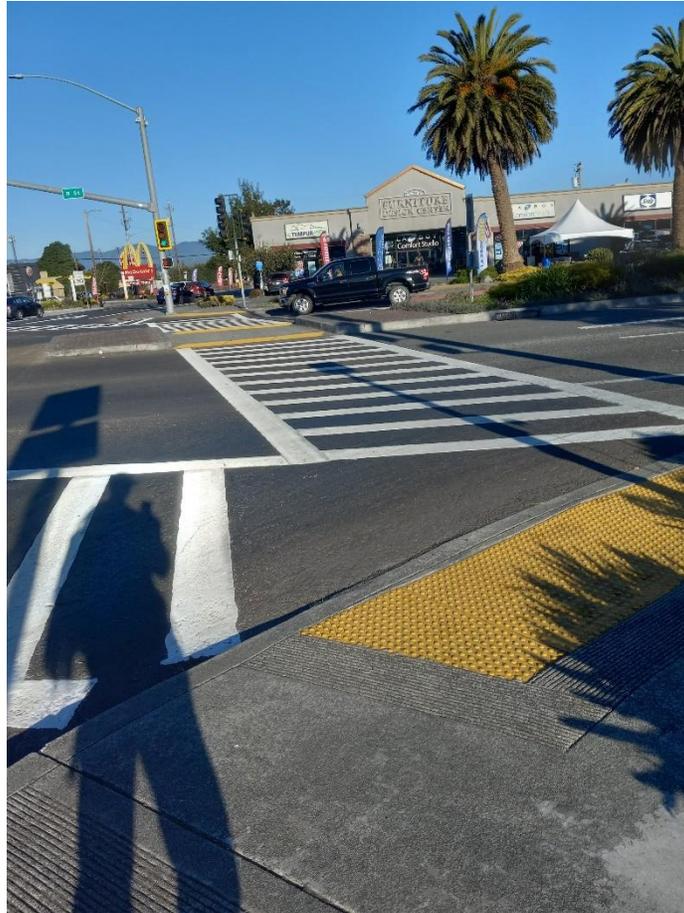
Participants appreciated the presence of traffic signals with accessible pedestrian signals (APS) at the intersections of 4th and 5th Streets with R Street/SR-255. However, they noted that the signals do not provide enough time for slower-moving pedestrians to cross, especially crossing R Street at 5th Street. They also noted that the APS was not loud enough to be heard above the sound of traffic.

Figure 24: 5th and R Streets, featuring a very long crosswalk and a wide vehicle right-turn radius with a misaligned curb ramp.

Increase pedestrian signal timing to allow ample time for seniors and other slow-moving pedestrians to safely cross the street. Increase the volume of the APS so it can be heard above the traffic noise.

Narrow right-turning radius at both intersections to slow turning speeds. Prohibit right turn on red at these intersections.
