# McKinleyville Middle School Walkability Assessment Outcomes

May 15, 2019

Humboldt County Department of Health and Human Services Public Health Branch &  
Natural Resources Services Division of Redwood Community Action Agency

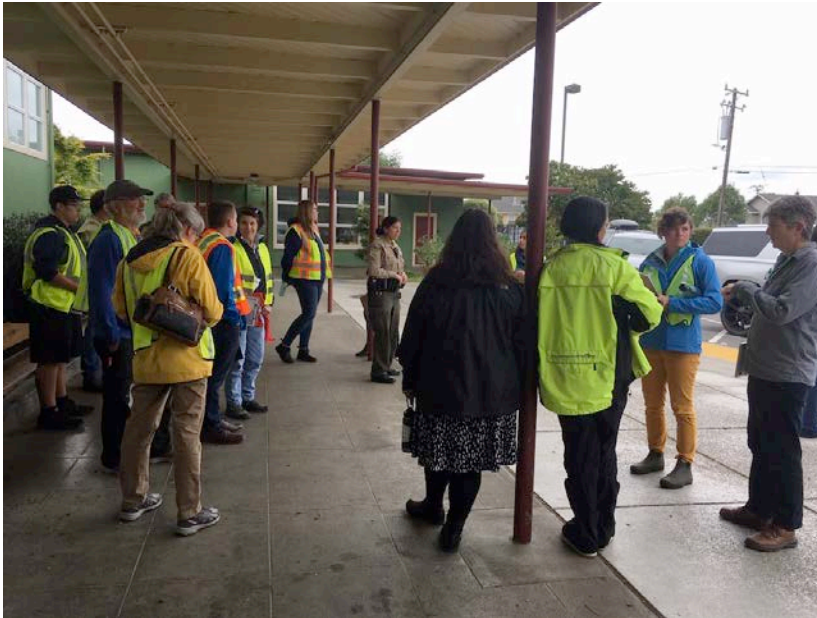
Participants first observed the arrival/dismissal area in front of McKinleyville Middle School before continuing along the walking route. The school has a loading zone adjacent to the school office as well as another loading zone in the front parking lot. Students are instructed to walk along the sidewalk around the front parking lot to get to the Central and Railroad intersection.

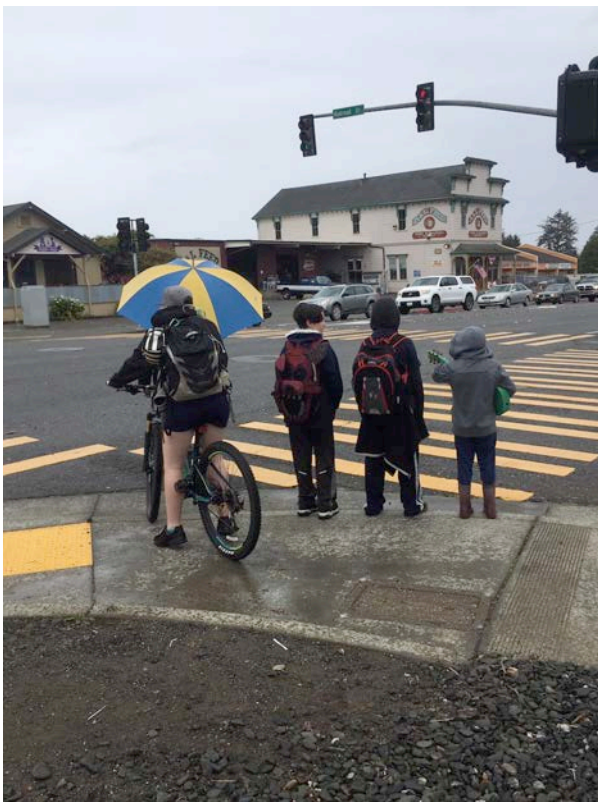
Long/wide crossing distance on Central Ave.  
Congested pedestrian crossing waiting area at Central and Railroad  
Speeding cars on Central trying to get 'in front of traffic' where lanes merge at Railroad  
Left turn exiting MMS does not detect bicycles  
No crosswalks across shopping center driveways on Hiller  
Cars speed around corner from Hiller into shopping center on Pickett  
Lack of consistent striping and pedestrian and bicycle facilities on Hiller Ave.  
Hiller Ave has inconsistent widths and is mostly very wide  
Lack of lighting along Hiller Ave.  
No Posted speed limit on Hiller Ave.  
Intersection at Hiller and McKinleyville Avenue is wide, not squared, and lacks crosswalks  
Bike lanes end south of Hiller on McKinleyville Ave.  
Lack of directional signage for cyclists to the Hammond Trail  
Proposed 'town center' will need planning for safe ped/bike access  
Utility poles cause obstructions along McKinleyville Ave and Railroad Drive

**Figure 1: Waiting area to cross Central is small and crowded.**

<b>Location</b>	<b>Observation</b>	<b>Recommendation</b>
School	Distracted walking	Education Expectation Station
School	Students not wearing helmets	Education Expectation Station Positive reinforcement campaign
School	Bad air quality	No Idling campaign!
School	Kids cutting corners in parking lot	Education/Expectation Station
School	Not a lot of kids using back access	Education
Timothy Rd. entrance	Noise complaints	Education for students on being respectful Education for parents on being courteous Education for neighbors on benefits
Gas station/ ENF	Parents picking up students in offsite locations	Have a planned offsite drop off/ pick up location such as Church two blocks south
Railroad & Central	Potential ped/car conflicts from left turn lane exiting school	Create advanced ped crossing
Railroad & Central	Crosswalk monitor not visible	Provide yellow reflective vest
Railroad & Central	Crowded corner at south east intersection	Extend/enlarge waiting area for peds Install side gate and walkway/path towards ENF to direct peds away from corner

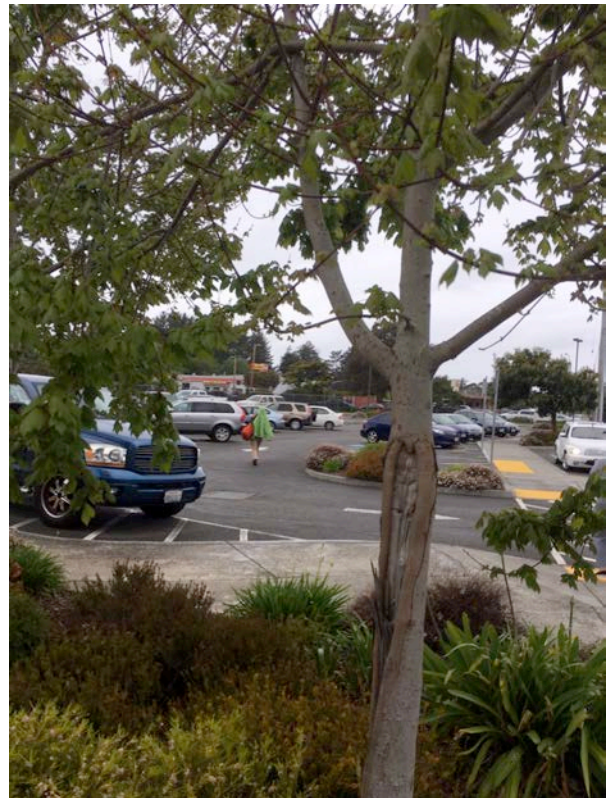
Students on bikes and skateboards without helmets  
Students walking distracted while on phones  
Students cutting diagonally through ENF parking lot  
Fear of ped/car conflicts at driveways at ENF and along Central Ave.

**Figure 2: Students cut across the Central Ave. businesses parking lot.**

<b>Location</b>	<b>Observation</b>	<b>Recommendation</b>
ENF	Parents picking up in ENF parking lot	Create safety procedures and agreement for students/parents to sign
ENF	Ped/car conflicts on ENF driveways, cars turning too fast	Paint "LOOK" or yellow stripes across driveway entrances
ENF	Students cutting diagonally through ENF lot	Education/Work with businesses to hang signage with same language as expectation stations Paint yellow stripe with warning message on driveway sidewalk Provide reflective tape/stickers to students Team up with businesses, such as The Club, for activities/education
Central	Narrow sidewalk	Widen sidewalk
Central	Speeding	Install speed radar when speed changes to 25 Extra patrols Educate drivers to slow in school zone Install flashing lights 30 mins. before/after arrival/dismissal
Central	Crosswalk leads to bike lane/nowhere at Sushi Spot, awkward	Create connection from crosswalk to sidewalk

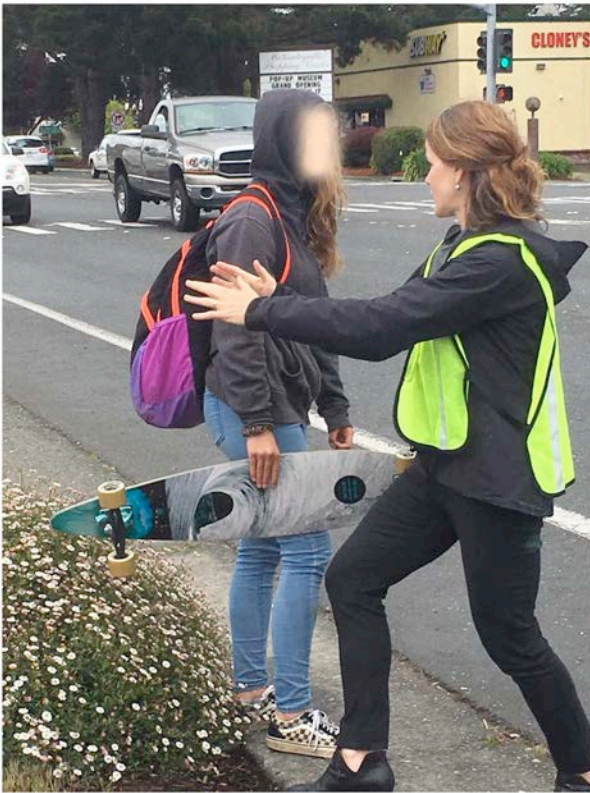
**Figure 3: Students were seen on bikes and skateboards not wearing helmets.**

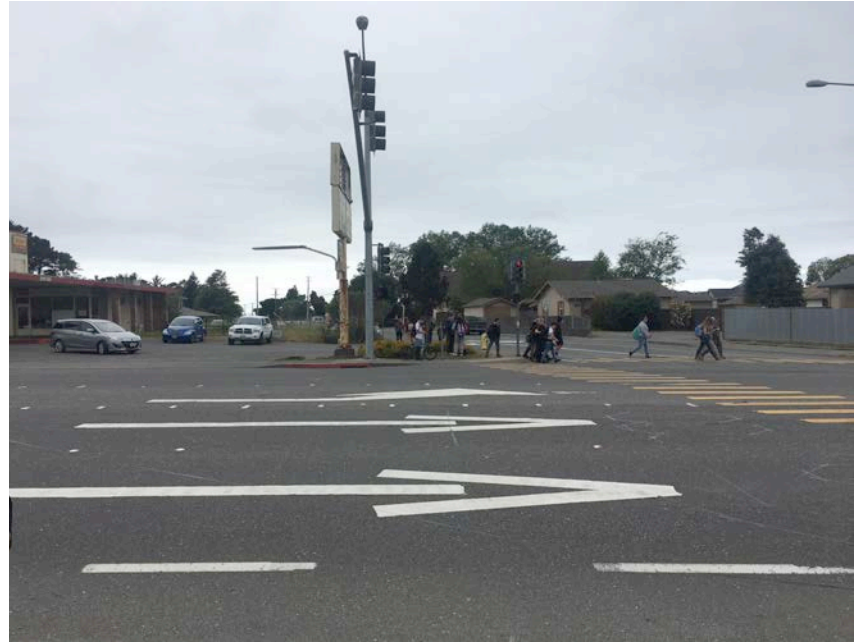
**Figure 4: Central Ave. has a wide crossing distance at Railroad.**

Railroad & Central	Long crossing distance (odd angle) Not enough time to cross the street	Re-orient and restripe crosswalk During arrival/dismissal have a Leading Pedestrian Interval and longer ped crossing period, Install Median island
Railroad - Central	Northbound cars speeding in right lane to get 'in front' of where lanes merge north of Railroad	Conduct County traffic study Create right-turn only lane into MMS Move merge lane arrows before Railroad
Railroad & Central	Left turn out of school (going southbound) doesn't detect bikes	Install in-road bike detection for signal
Central	Green bike lane ends	Extend green bike lane to school
Central	Safeway xwalk leads to nowhere

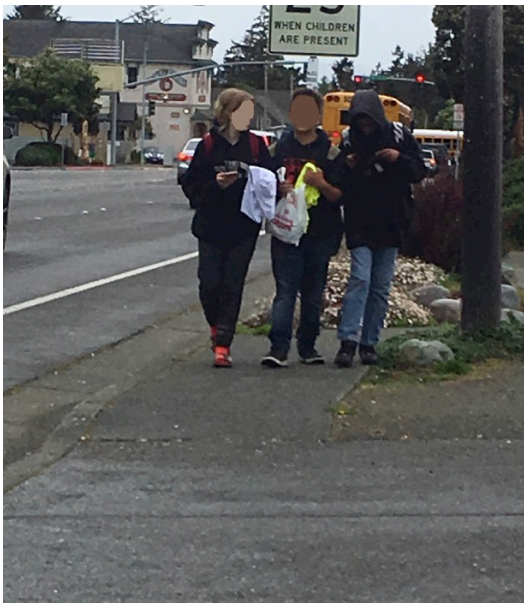
**Figure 5: Concerns about pedestrian/car conflicts at driveways in front of Central Ave. businesses.**

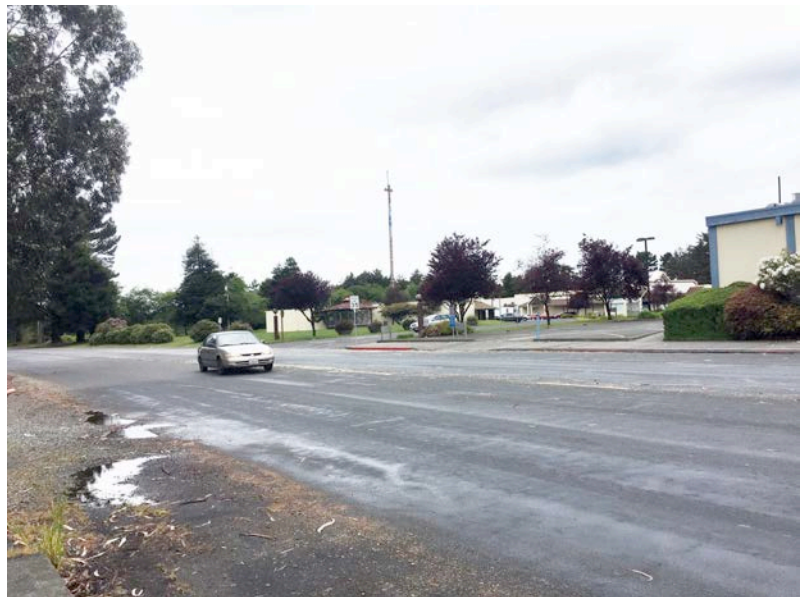
**Figure 6: Lack of crosswalks across driveways leading from Hiller into shopping center**

<b>Location</b>	<b>Observation</b>	<b>Recommendation</b>
Hiller & Central	Lacks sidewalks, difficult for strollers. Sidewalk only exists on north but not south side of street in one small area near FRC	Fill in sidewalk gaps
Shopping center	Long crossing distance on driveways	Paint crosswalk & repaint STOP
Shopping center	Cars speeding in and out from/to shopping center (Pickett) from/to Hiller	Paint sharper radii on turn Install BOTS DOTS
Shopping center	Lack of sidewalk to shops/not ped friendly	Install sidewalks
Hiller	Wide street	Paint bike lanes/fog lines
Hiller	Lots of debris in shoulder	Maintain shoulder
Hiller	Dark at night	Install pedestrian scale lighting
Hiller	No striping or bike lanes	Install fog lines or bike lanes
Hiller	Speeding/ inconsistent width of lanes	Install bike lanes/fog lines Speed tables/humps Speed radar signs Narrow lane width/chicanes
(McK Family Resource Center)	Overgrown bushes	Trim vegetation

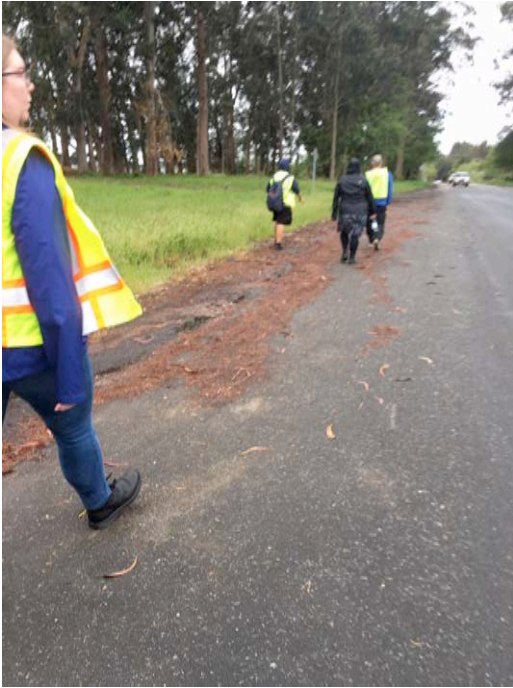
**Figure 7: Inconsistent striping and lack of sidewalks and pedestrian lighting on Hiller Ave.**

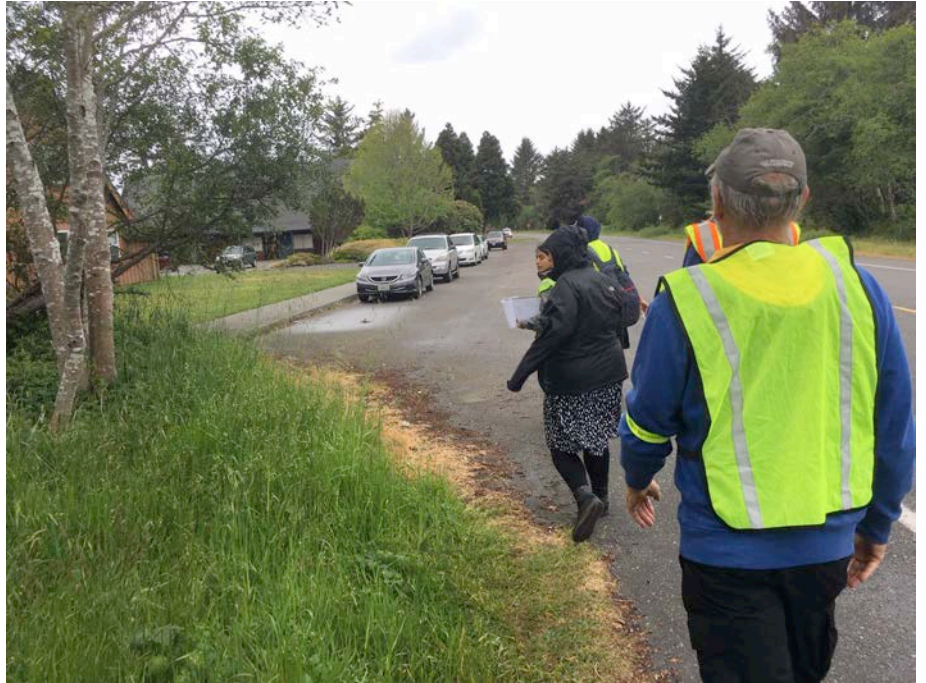
**Figure 8: Wide street/inconsistent street width lacking bike lanes on Hiller Ave.**

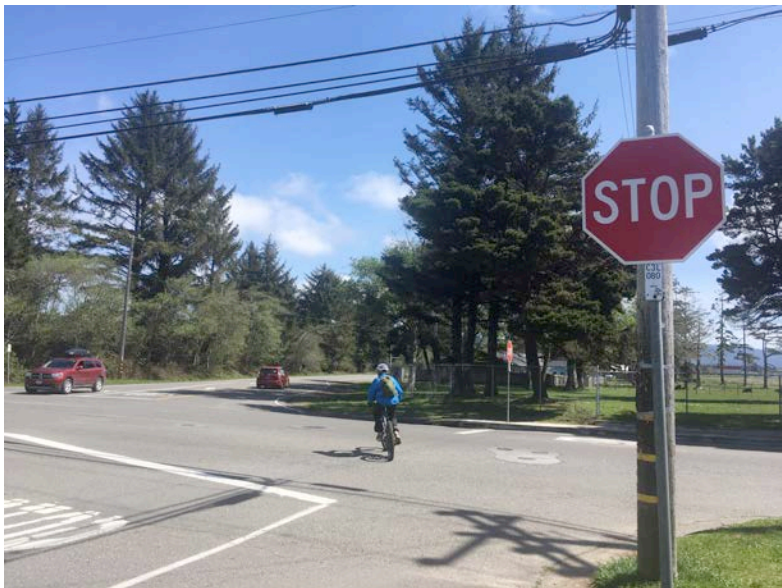
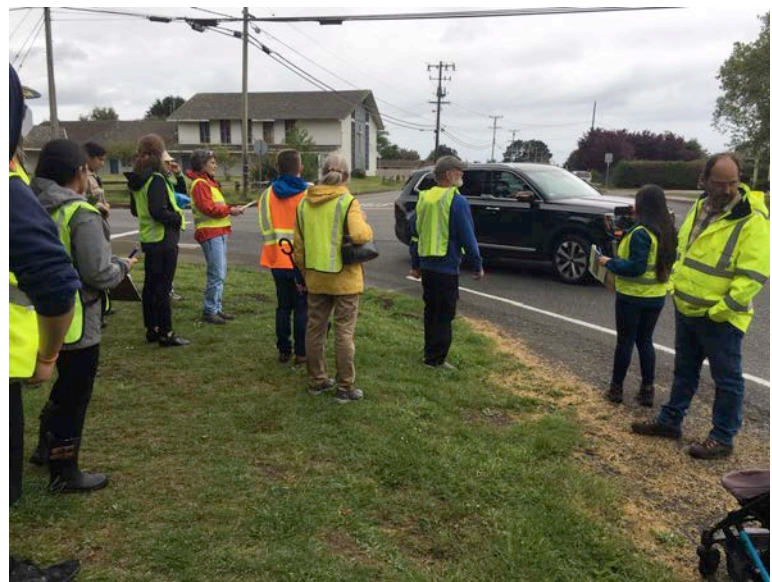
**Figures 9 &10: Irregular intersection at Hiller and McKinleyville Ave. is not squared and is awkward for pedestrians, cyclists, and motorists.**

Hiller	Lack of speed limit signs	Install speed limit signs
Hiller & Mck Ave.	Hammond Trail location unknown	Install Hammond Trail way finding signs
Hiller & Mck Ave.	Wide/ not squared intersection, traffic lanes not marked, lack of clear directions	County should redesign 'Neck' in or reshape intersection first with paint, then curbs if funding available. Extend sidewalk on McK Ave. further north on SE corner. Extend stop sign on McK Ave. further north to increase visibility of peds. Create improvement plan. Install crosswalks in each direction. Install traffic circle

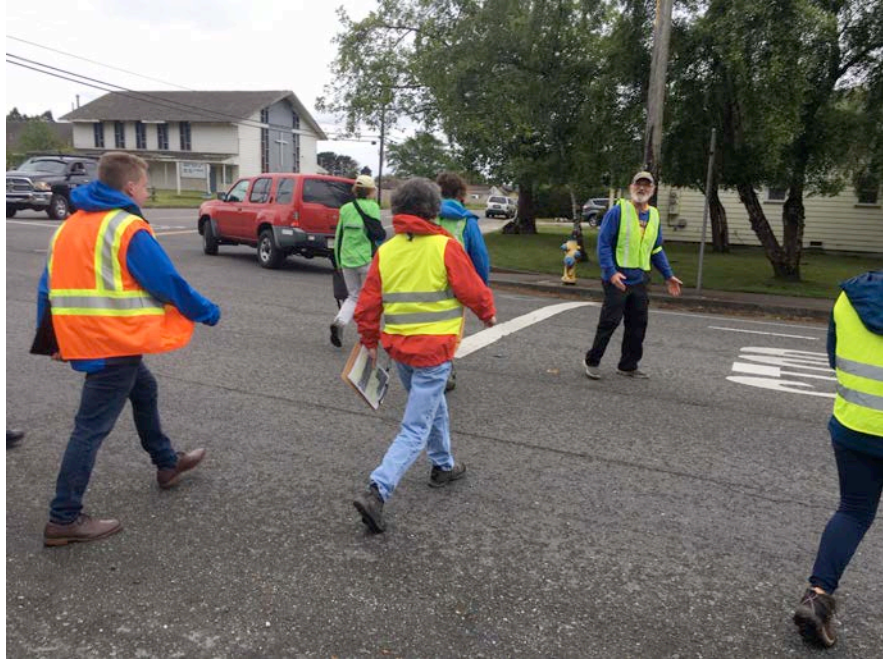
**Figure 11: Intersection at Hiller and McKinleyville Ave. lacks crosswalks or a clear way to cross safely.**

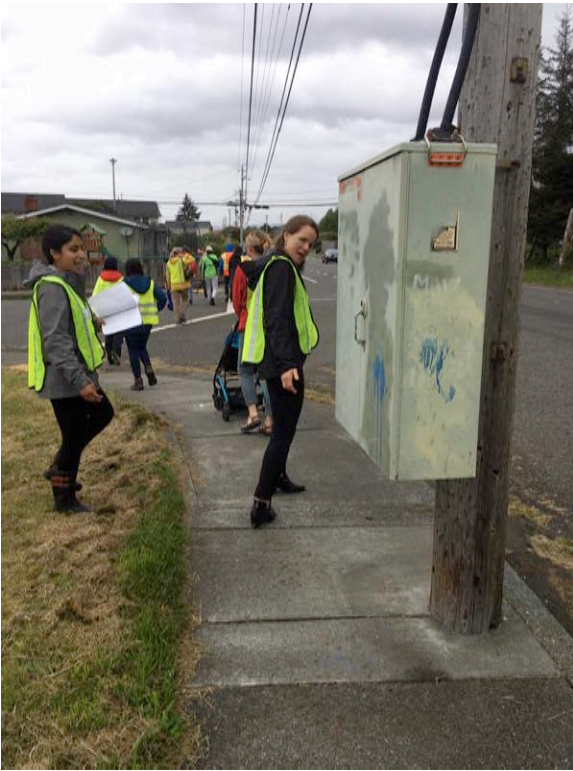
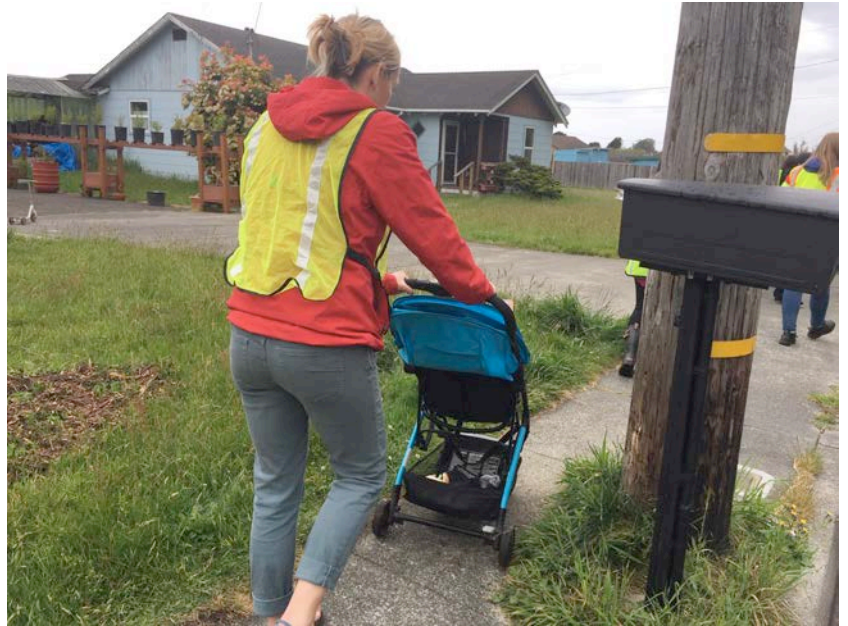
assisted mobility devices or pushing strollers. One residence had created a wider swath of sidewalk around a utility pole by expanding the sidewalk into the grass on their property creating easier access for pedestrians around the pole. The group crossed Railroad Drive, then used the crosswalk to cross McKinleyville Avenue and headed east on Railroad Drive. At Central Avenue, the participants crossed the street then crossed Railroad Drive and walked back onto campus reconvening in the conference room.

**Figures 12 & 13: Many utility poles obstructing sidewalks on McKinleyville Ave.**

<b>Location</b>	<b>Observation</b>	<b>Recommendation</b>
Mck Ave.	No bike lane on Mck Ave. south of Hiller	Install bike lane
Mck Ave.	Utility pole obstructions on sidewalk	County extend pavement around poles. Encourage homeowners to do it (use existing example)
Mck Ave.	Students biking against traffic, people walking on bike lanes	Education
Mck Ave.	Speeding motorists	Install permanent or temporary speed radar. Install speed humps. Education campaign at elementary and high school
Mck Ave.	Bike lane debris/obstructions	Clean and maintain
Mck Ave.	No crosswalks to side streets	Install crosswalks Install signs 'Cross at ___street'
Mck Ave.	Dark at night and early mornings	Install ped scale lighting
Mck Ave.	Cars parked against traffic	Education
Mck Ave.	Faded bike lane	Repaint
Mck Ave.	Bike lane located in 'door zone' –close to parked cars	Education for cyclists and motorists Encourage 'Dutch Reach'
Mck Ave.- Midfield	Wide intersection, electric pole/utility box obstruction	Install bulbouts around utility pole and on each corner to reduce crossing distance

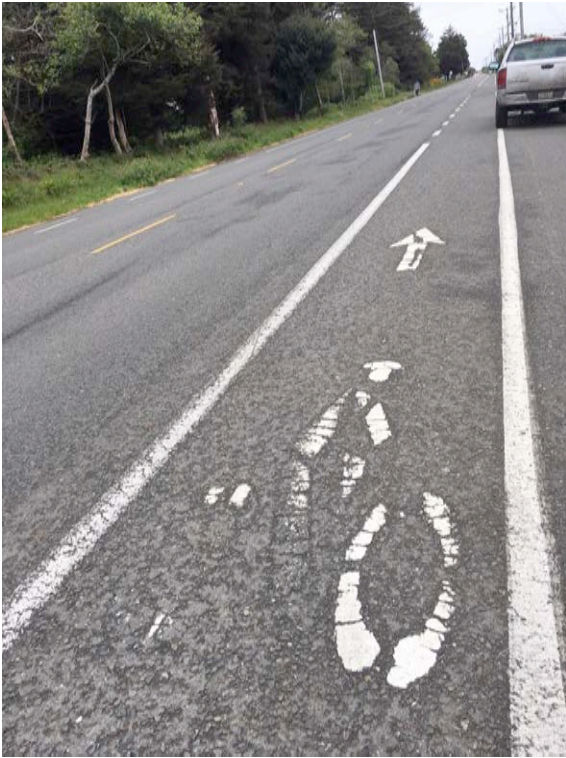
Bike lanes on McKinleyville Ave. and crosswalk at Railroad and McKinleyville Ave are faded

**Figure 14: Bike lane is faded on McKinleyville Ave.**

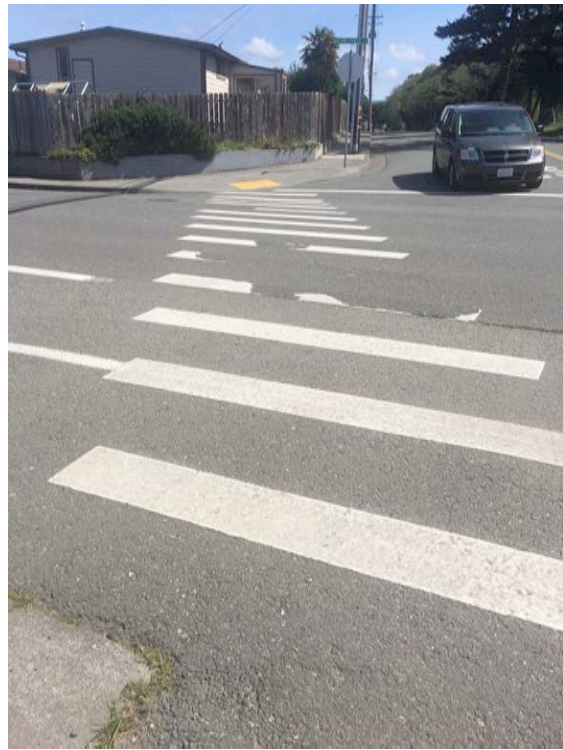
**Figure 15: Crosswalk at McKinleyville Ave. & Railroad Dr. is faded.**

Mck Ave. & Railroad	Faded (north) crosswalk	Repaint
Mck Ave. & Railroad	SE corner with "ramp to nowhere"	Connect curb ramp to sidewalks on McKinleyville Ave. and Railroad Drive

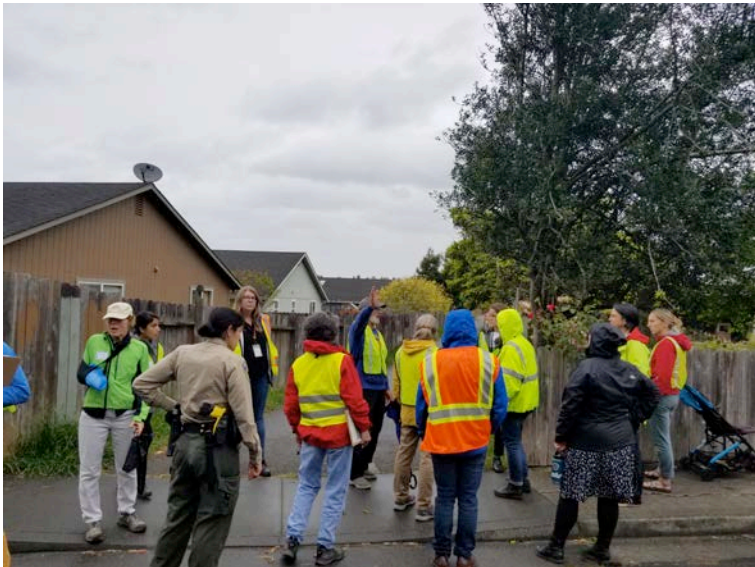
**Figure 16: The Mid-Town Trail lacks cautionary and directional signage.**

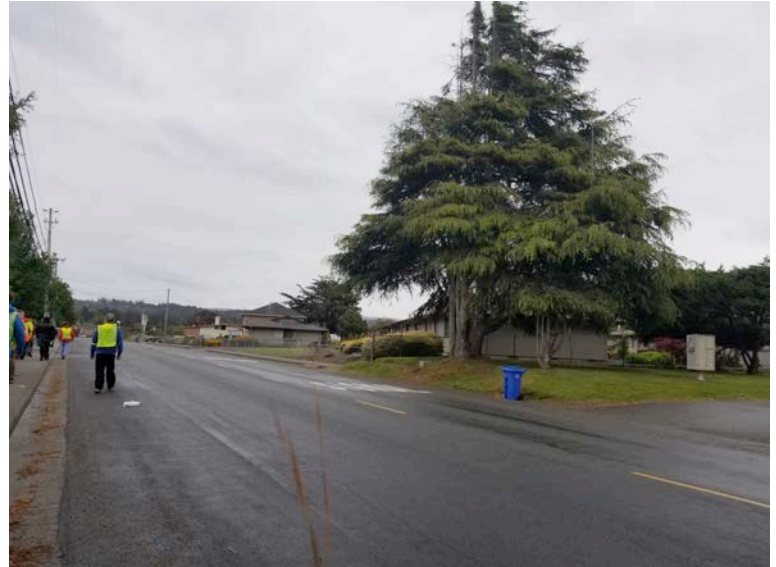
SE corner of Railroad Drive and McKinleyville Ave. 'ramp to nowhere' with non-existent sidewalks  
Motorists speed on Hiller Ave., McKinleyville Ave. and Railroad Drive  
Inconsistent sidewalks on Railroad Drive  
Railroad Drive lacks lighting and bike lanes  
Wide turn radius from Railroad onto Silverbrook causes fast turns by motorists  
Lack of cautionary and/or directional signage at Mid-town Trail  
Senior housing on Railroad Drive has no sidewalks or ADA leading to/from it

**Figure 17: Railroad Dr. is wide street lacking striping and bike lanes. Motorists often speed.**

<b>Location</b>	<b>Observation</b>	<b>Recommendation</b>
Railroad	Inconsistent sidewalks	Fill in sidewalk gaps
Railroad	Lack of bike lanes	Restrict parking on north side and add bike lanes on both sides of the street
Railroad	Speeding cars	Install speed tables/humps Temporary or permanent speed radar sign
Railroad	Overgrown vegetation	Trim
Railroad	Senior housing 'island' - No ped access to senior housing	Fill in sidewalk gaps and add ADA
Railroad	Limited lighting	Install ped lighting
Railroad	Utility poles obstructing sidewalks	Extend sidewalk around poles
Railroad & Silverbrook	Wide turn radius	Sharpen turn angle with paint
Mid-town Corridor	Lack of awareness	Install Mid-Town trail sign Install "expect bikes/ peds"
Railroad & Central	Overgrown tree covering Bus Stop sign	Trim vegetation Install bus shelter
